Whitehead Lodges

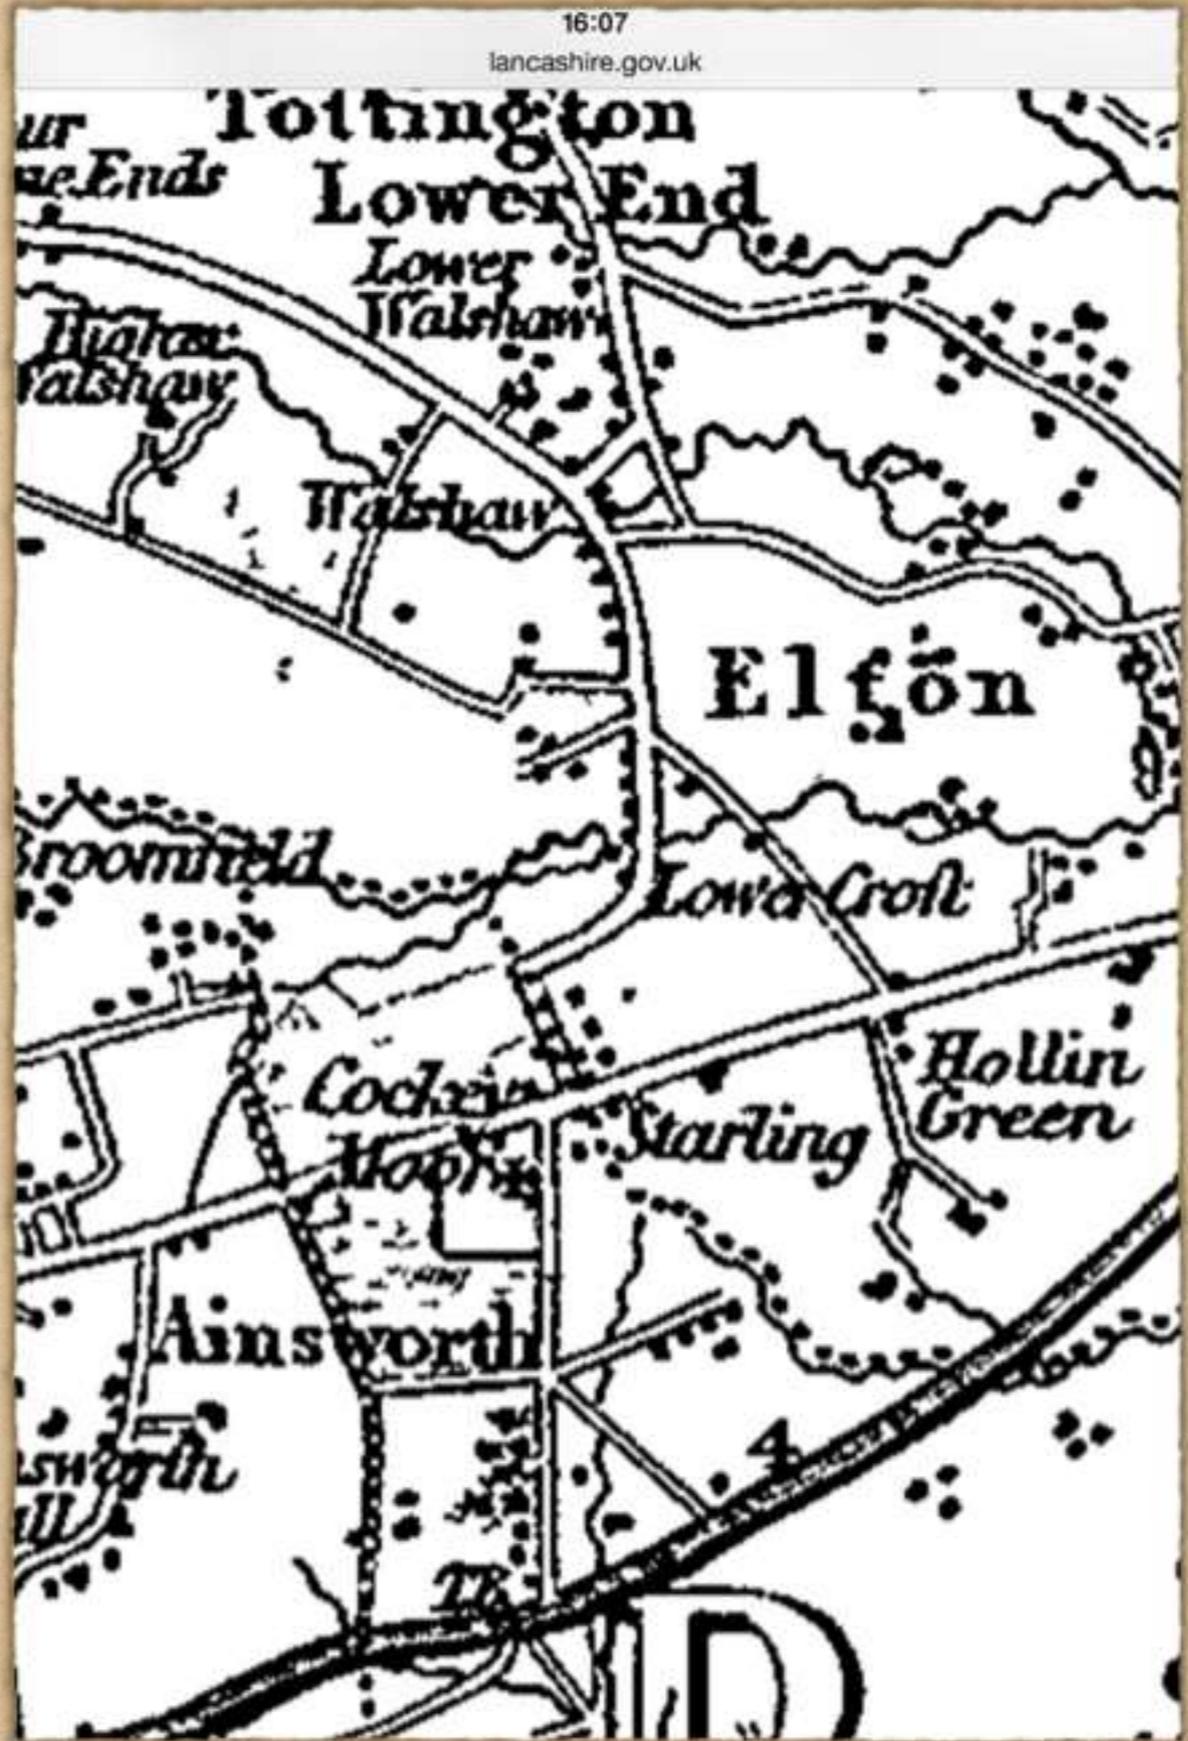
Yates Map  
1786

Tottington Mill Print Works was started by Joshua Knowles in 1820 on the site of an old corn mill for which the bottom lodge had probably been built. Its business was calico printing of fabric, rather than paper, and it had five printing machines plus 95 hand-block printing tables in 1841, and seven machines by 1846. The site employed over 400 people at its peak of whom about a quarter were under the age of 13. Yates map of 1786 shows the two brooks that now feed the top and middle lodges but no lodge or reservoirs

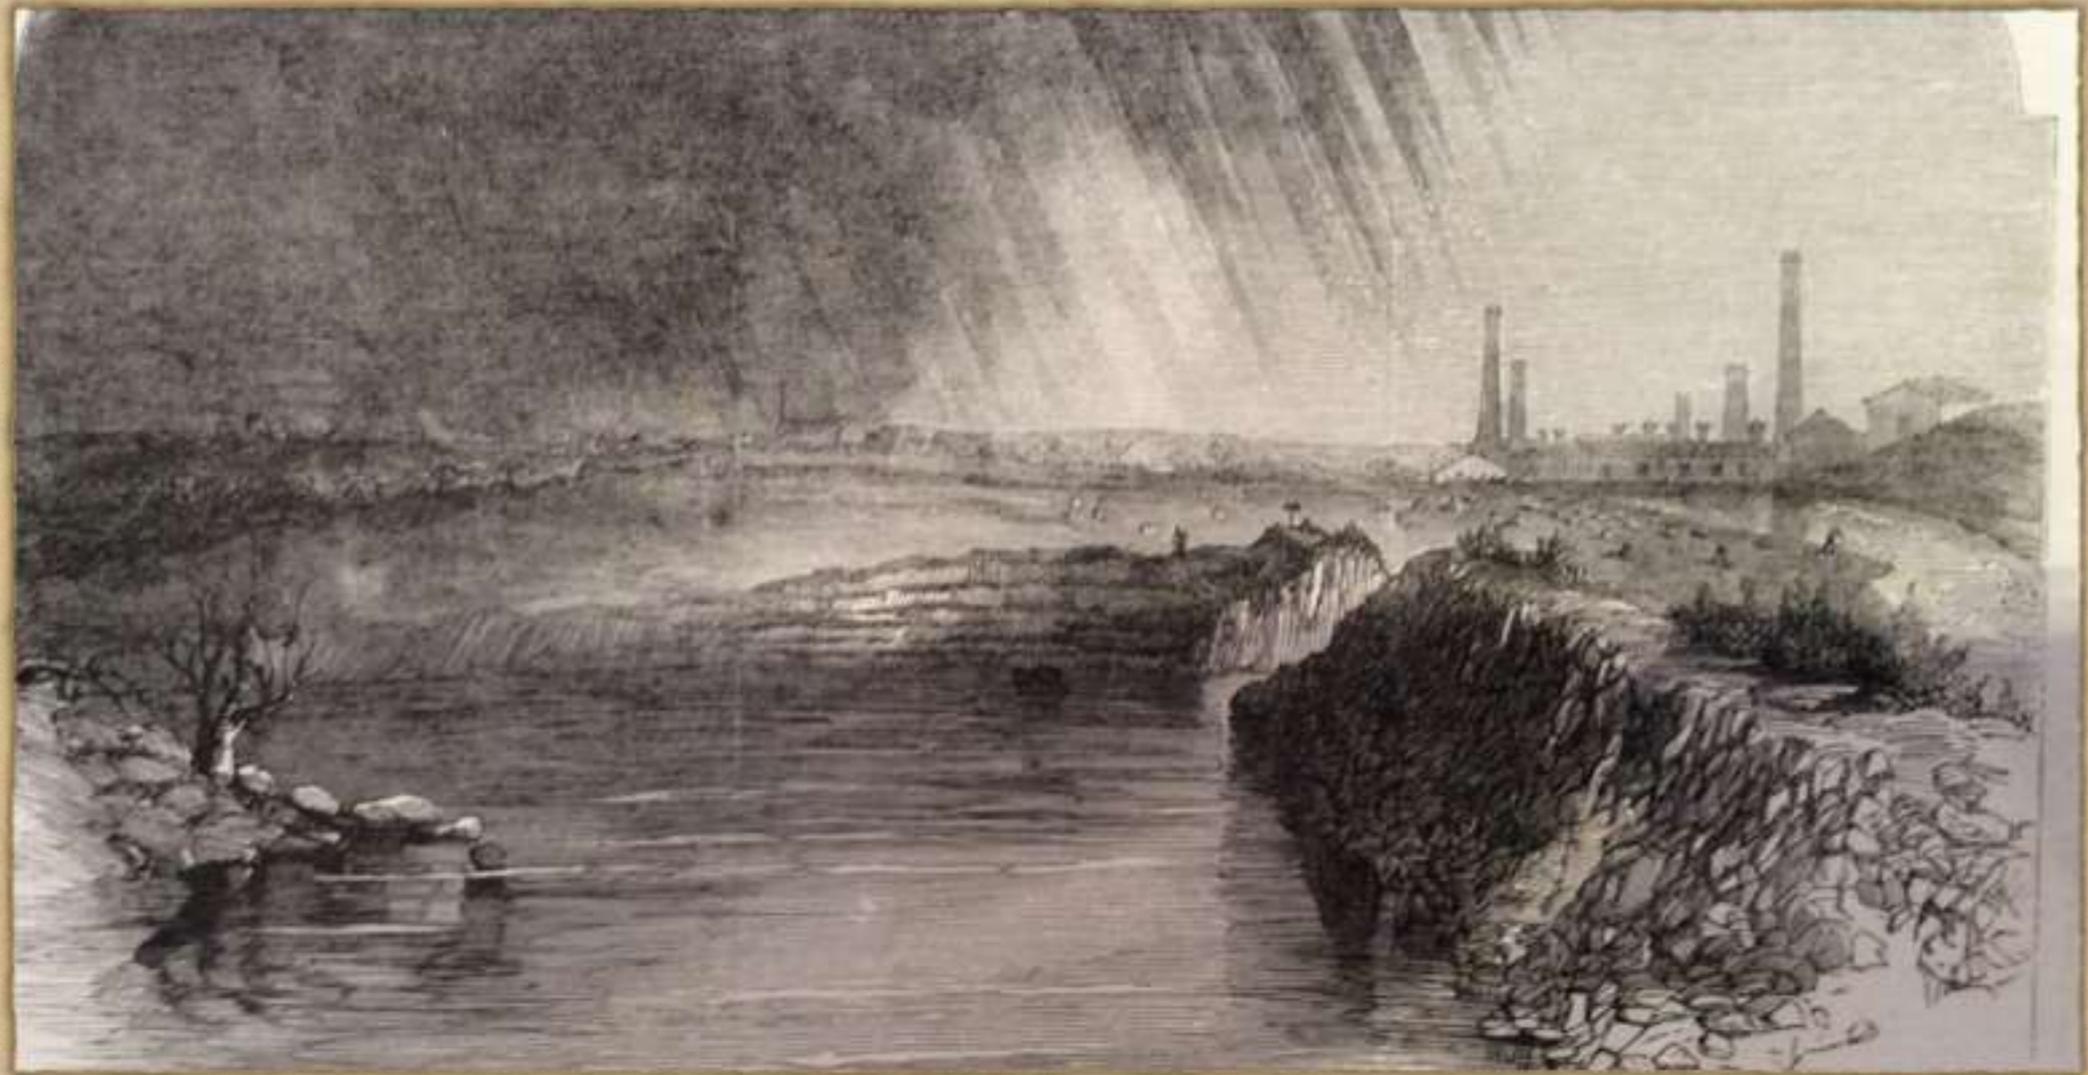
Breach of Middle lodge  
December 5th 1852  
(from London News)

At 7am on the Sunday morning (December 5th 1852) the reservoir breached, by 9am a hole 40" wide and 36ft high had opened up in the embankment. Water rushed into the bottom lodge where it was temporarily checked.

The lower lodge was soon breached flooding the die works and picking up a 4 ton wagon which narrowly missed destroying the base of one of the chimneys. All the ground floor windows in the mill were destroyed and the costs to Mr Whitehead were estimated at £15,000.

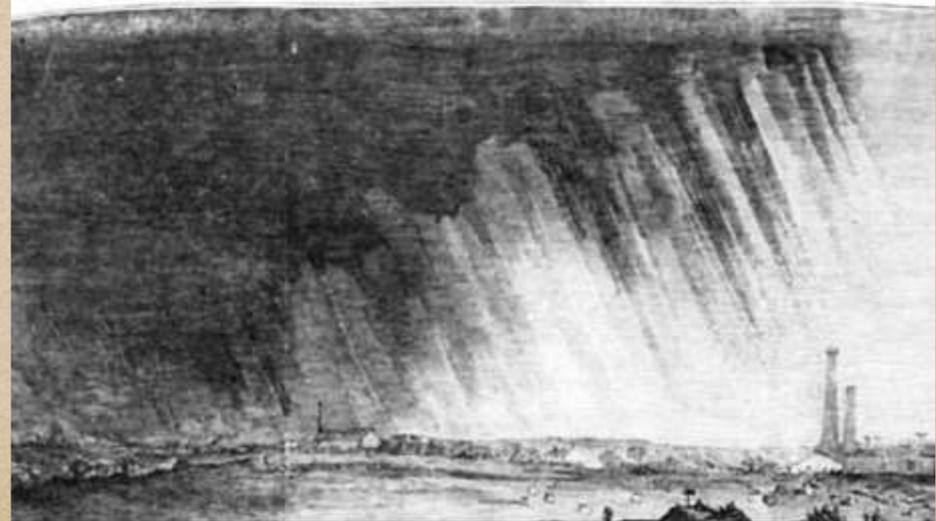
**BURSTING OF THE RESERVOIR AT BURY.**

This destructive inundation was fully detailed in our Journal of the 11th inst. The illustration shows, in the fore portion, the remains of the burst Reservoir and embankment. In the right is seen the breach through which the water rushed, and swept onwards to Mr. Whitehead's dye and bleach works, consisting of a group of buildings occupying about an acre of ground.

The "Lodge," as the Reservoir is called in the neighbourhood, is an accumulation from Little Heath stream rising to Cuckney-pool. An immense embankment thrown across the valley at this point served to retain the waters of the Reservoir. Owing to the heavy fall of rain during the previous week, there was an immense body of water in the Reservoir at the time of the accident, and it became a source of serious and well-founded alarm to the inhabitants of the district. During the whole of the preceding night the rain fell in torrents, and numbers of people were on the embankment anxiously watching the progress of the accumulation. About seven o'clock on Sunday morning (the 10th inst.) it became evident that the top-wash of the "Lodge" was no longer sufficient to carry off the surplus water, and almost immediately afterwards the water commenced making a clear breach over the central portion of the embankment. The earth being what is called the "backing," which supports the puddle-wall in the centre of the embankment, was first washed away. About nine o'clock the puddle wall, from which the backing had been washed, gave way to a body, and a breach, measuring 30 feet in length by about 40 in breadth, was made in the embankment. The pent-up water rushed from its lodgment in an immense volume till it reached the second reservoir, where it received a momentary check. A great portion of the flood swept completely

over this, however, while the right-hand side of the embankment had made two clean breaches, and made a cut

- The disaster was reported in the London News where this wooden engraved image appeared and in the Manchester Guardian

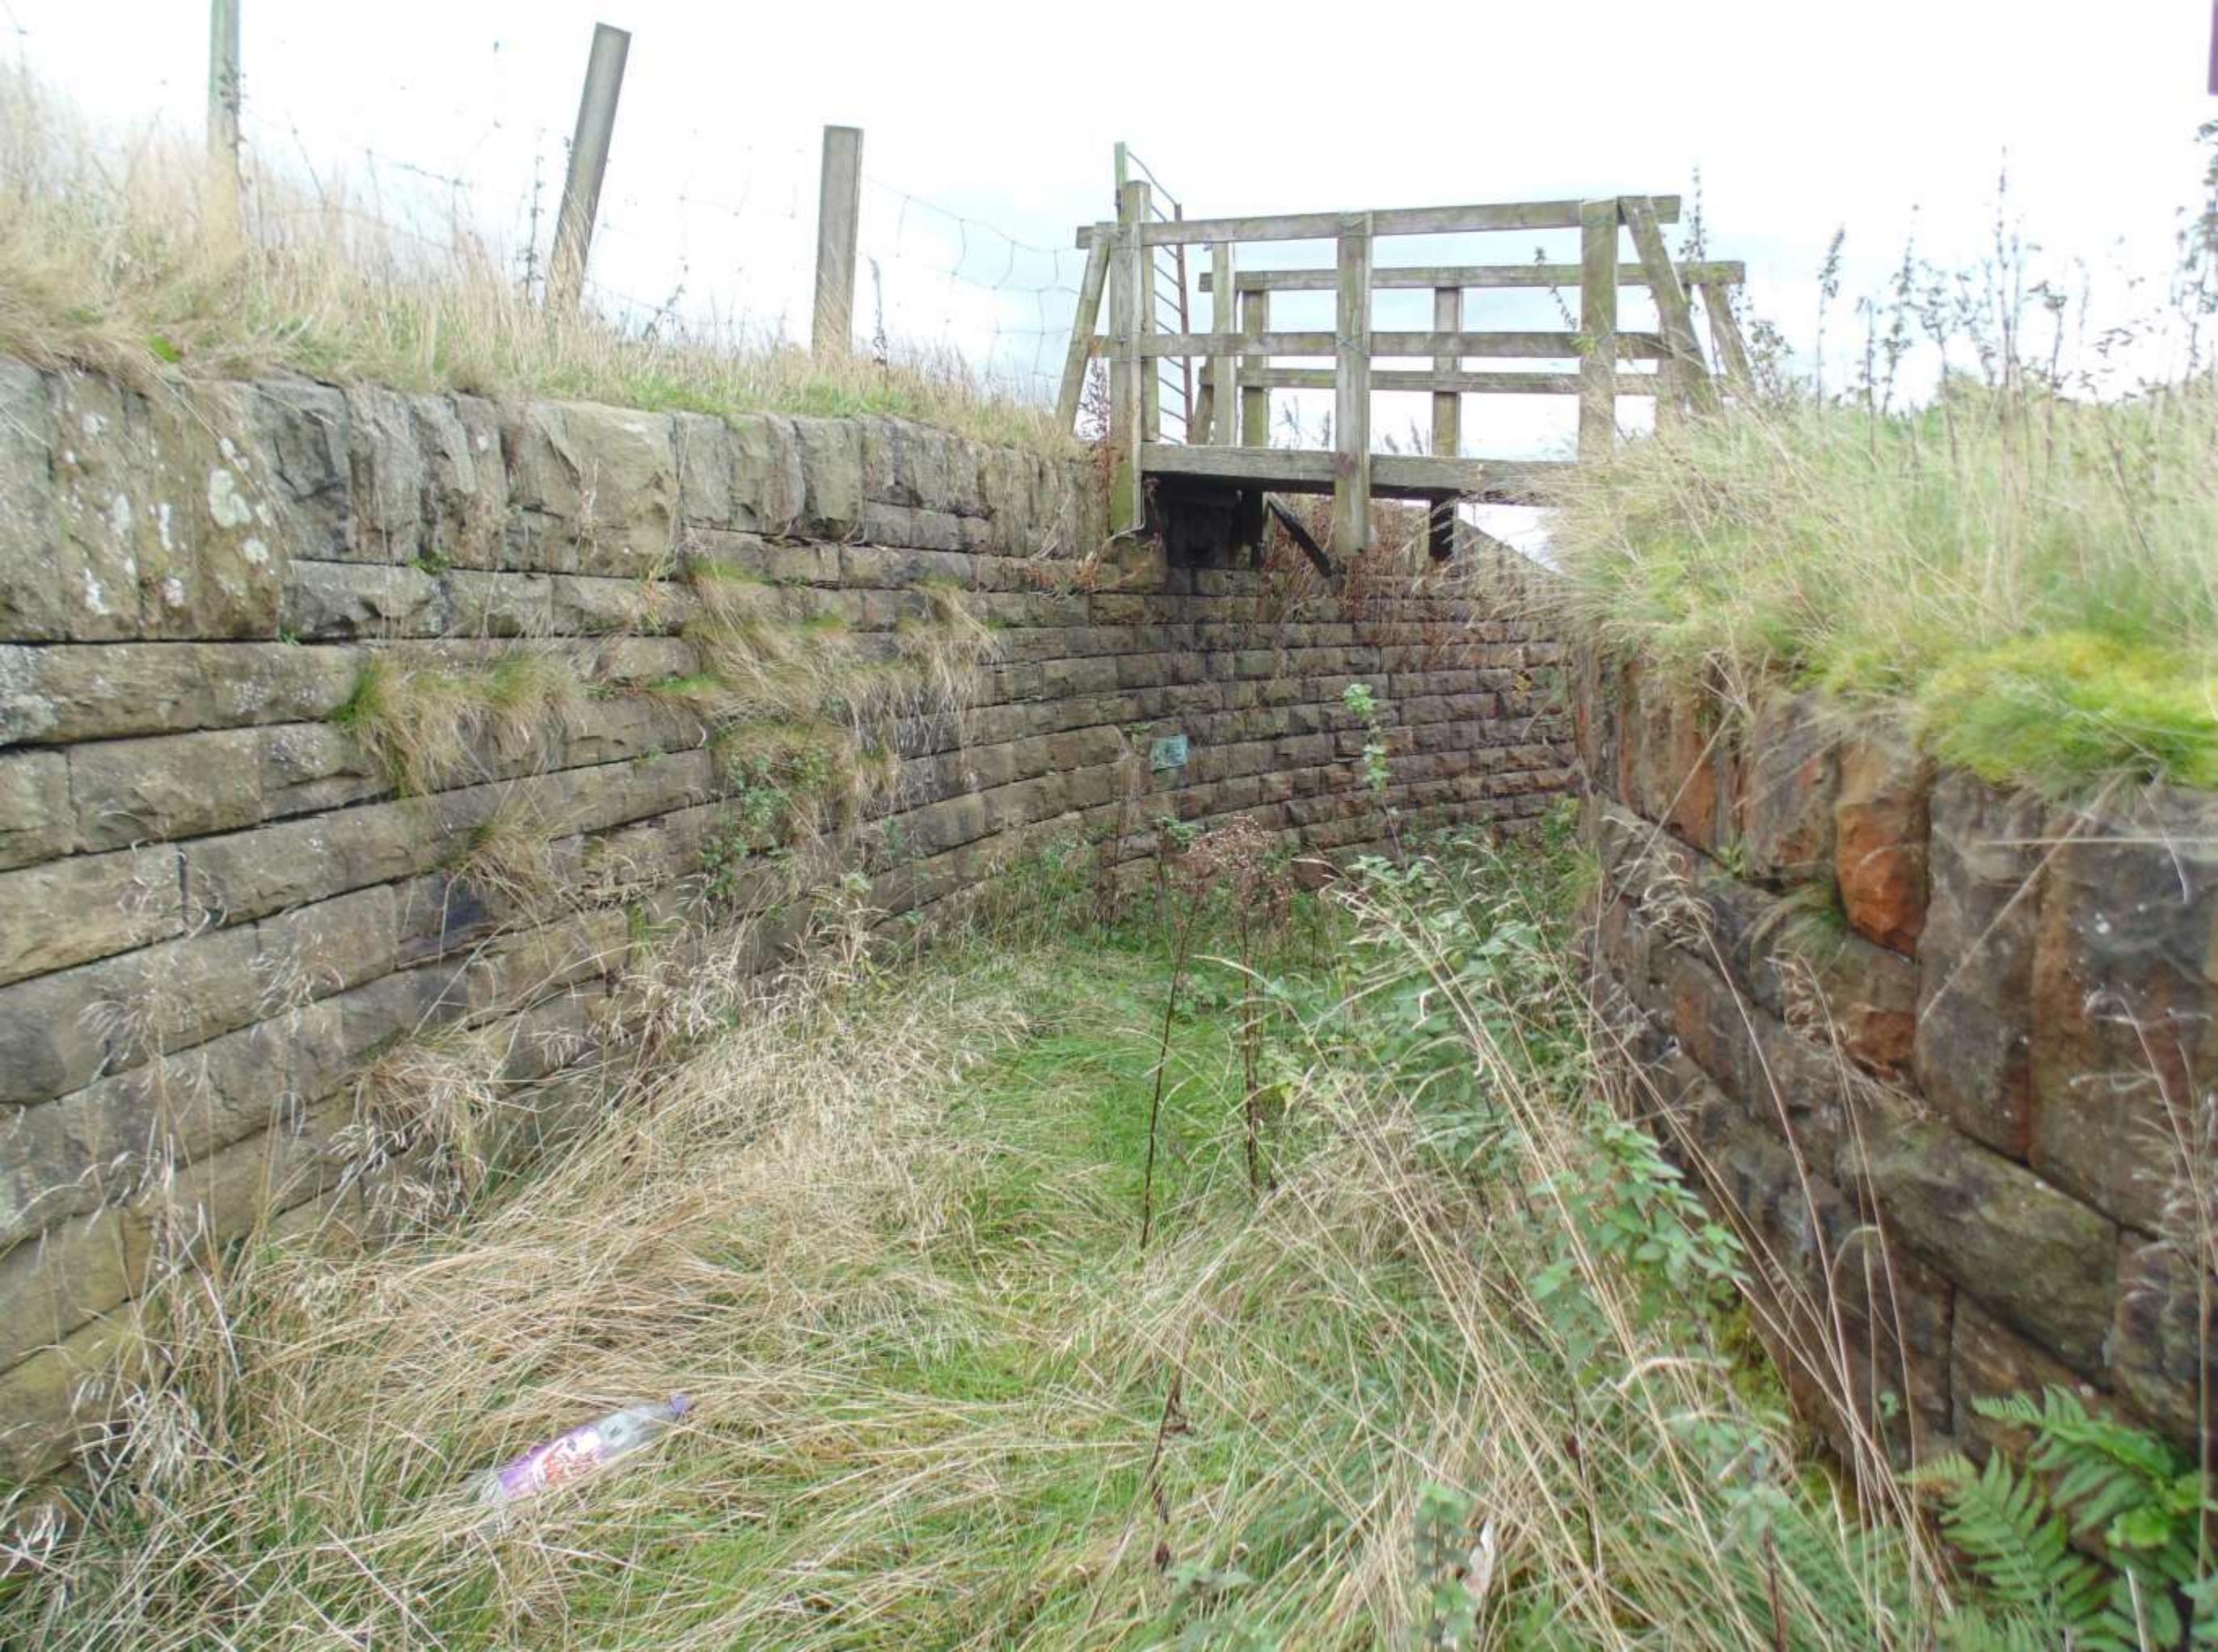
THE BOTTOM OF THIS PLATE MARKS THE HEIGHT  
OF THIS OVERFLOW SILL AS IT WAS PRIOR TO

20<sup>TH</sup> APRIL 1934

THE RIGHT TO RESTORE IT TO THAT HEIGHT  
IS RESERVED
